**18TH INTERNATIONAL FLOW MEASUREMENT CONFERENCE -  
FLOMEKO2019**

**DEFORMATIONS AND VOLUME CHANGES DUE  
TO MOISTURE VARIATIONS IN HERITAGE  
BUILDINGS - USE OF NDT TECHNIQUES**

Research Project “**COREAP**” – Service life, conservation and  
rehabilitation of walls of buildings with relevant patrimonial value”  
(Vida útil, conservação e reabilitação de paredes de edifícios de valor  
patrimonial)

**Laboratório Nacional de Engenharia Civil (LNEC)**

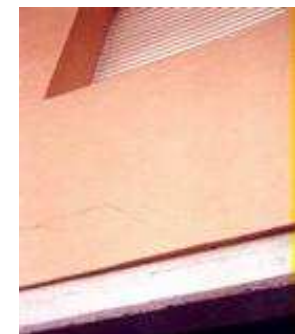
**Photogrammetry** can possibly give the first information about this case, when this creep deflection, mainly occurring in beams or pavements, is visibly considered **anomalous** and, clearly, these deformations can be, mainly, attributed to:

- **Creep**;
- **And, with less importance, to the moisture deformations.**

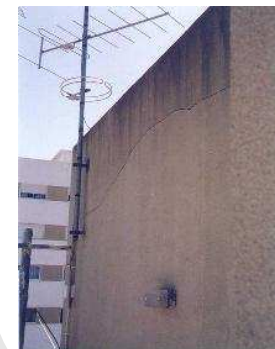
Photogrammetry can explore in detail the apparent state of the surface of the building element, namely:

- superficial defects associated to cracks.

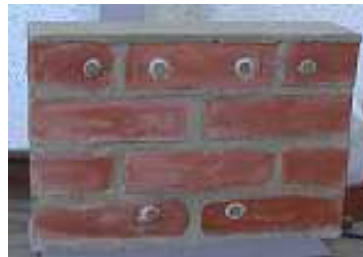
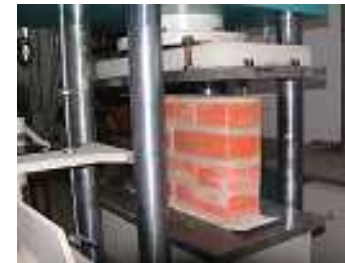
- Specimen test M1 was built with massive ceramic blocks, which have average dimensions of approximately 213 mm (length) x 108 mm (thickness) x 60 mm (height), and cement mortar joints (cement sand ratio - 1: 4 / volumetric ratio).

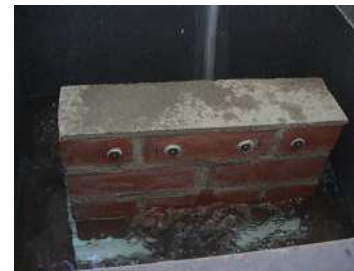
After retiring from immersion, a thermographic analysis was made.

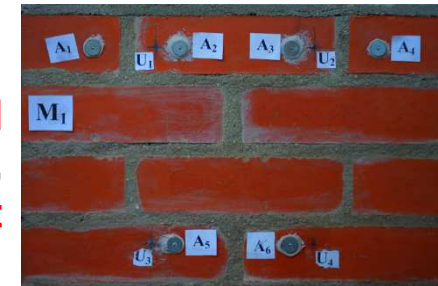
Deformations of the specimen M1 during 1st loading and initial part of 2nd loading phase (see comparison of results for load between 0 and 0.2 MPa)

The results of the measurement of deformations with alongameter in the specimen show that the variation of horizontal (A1-A3; A2-A4: see reading points) and vertical (A2-A5; A3-A6: see reading points) residual deformations, measured after discharge of the specimen, in end of each load step, were generally correspondent to a:

- gradual expansion of the specimen;
- and can detect, with the increase of load, the gradual progression of cracking (cracking which could affect, especially, measurement dv1/A2-A6 and dh1/A1-A3), that occurred in final part (after the 420 kN (8.90 MPa) of load) of the 3rd loading phase.

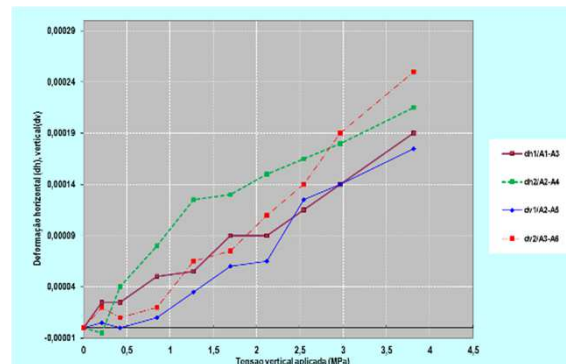
Deformations of the specimen M1 during 2nd loading phase

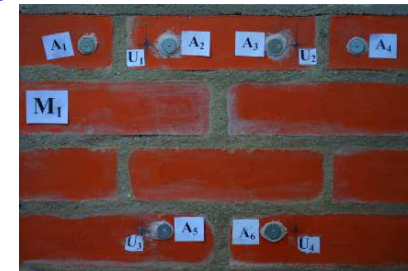
Ultrasound velocity (indirect measurements) of the specimen M1 during 1st loading and initial part of 2nd loading phase for the vertical applied load

Concerning the results of the application of ultrasound method in the specimen, the **indirect measurements** show that, in the **dry specimen**, with the application of the first load step of 10 kN (1st loading phase), there was an **increase of the ultrasound velocity measured after discharge of that load**, relatively to the correspondent value for 0 kN, for some of the measurements, namely:

- **horizontal** (U1/U2 (path with no mortar joints) and U3-U4 (path with one mortar joint));

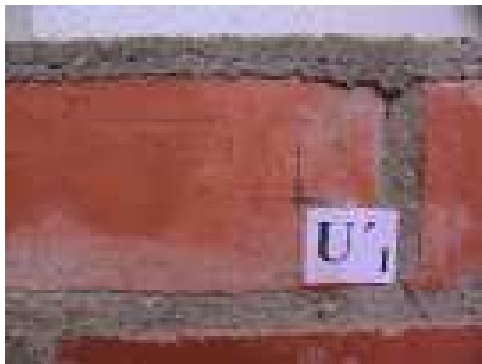
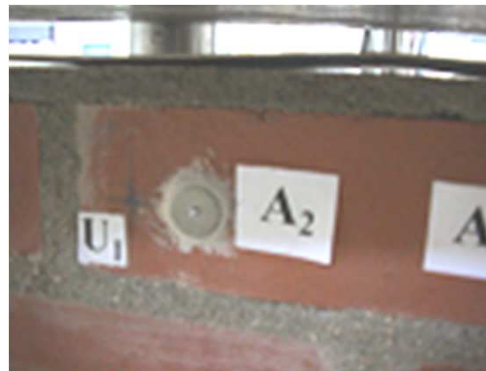
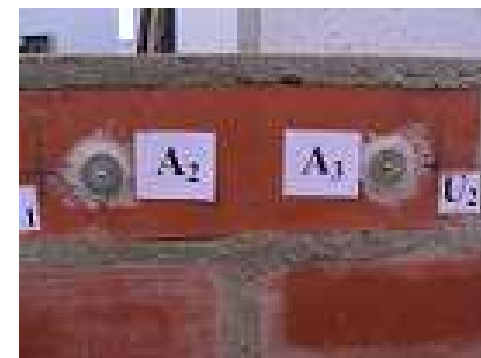
In the **3rd loading phase**, an **expressive reduction of velocity values** was observed, particularly, with the:

- **gradual progression of cracking on that loading phase** (cracking that affect, especially,  $U_1/U_2$  velocity values (indirect) and  $U_1/U_1'$  (direct), that occurred in final part of the load (after the 420 kN (8.90 MPa))

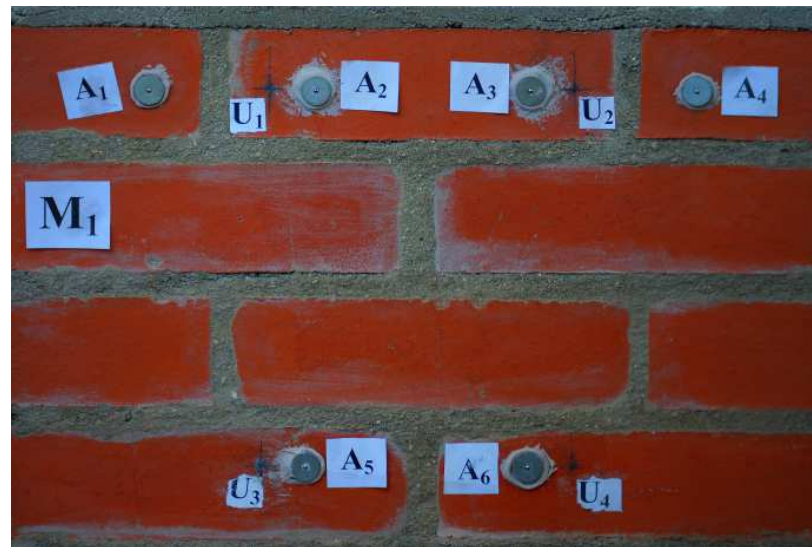
Concerning the use, in this test, of **photogrammetry**, to generate an **orthomosaic** (image that is the result of stitching several orthorectified images) with a pixel of 0.12 mm, it was necessary to make the **photo survey** with a **high quality digital camera**.

Orthomosaic of the surface.  
Pixel size 0.12 mm

Several photos were taken from **different locations** in front of the surface, but all at the same distance (70 cm).

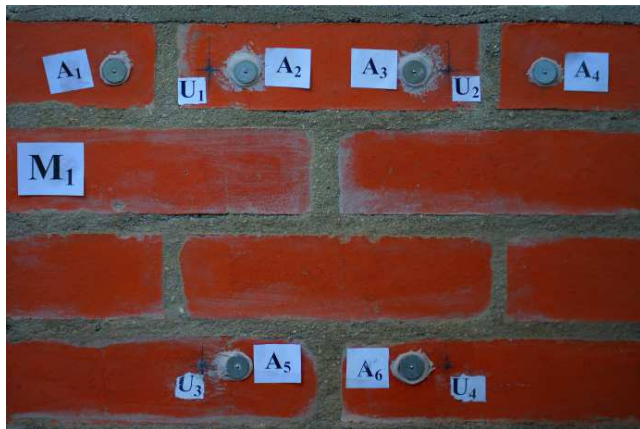
On Figure bellow (A and B) is presented the result of the **enhancement applied to the gray-scale version** of the image. Two types of edges can be detected.

- ❑ These were manually colored in Figure B.
- ❑ In **red** the **cracks**, only perceivable in the bricks since the mortar presents great **variability in intensity** (is a heterogeneous area, mixing pixel whites, blacks and grays).
- ❑ In **yellow**, the **borders between two different images** used to create the orthomosaic.
